6 Build Reports and Analysis

6.1 Overview of the DBDOC build reports

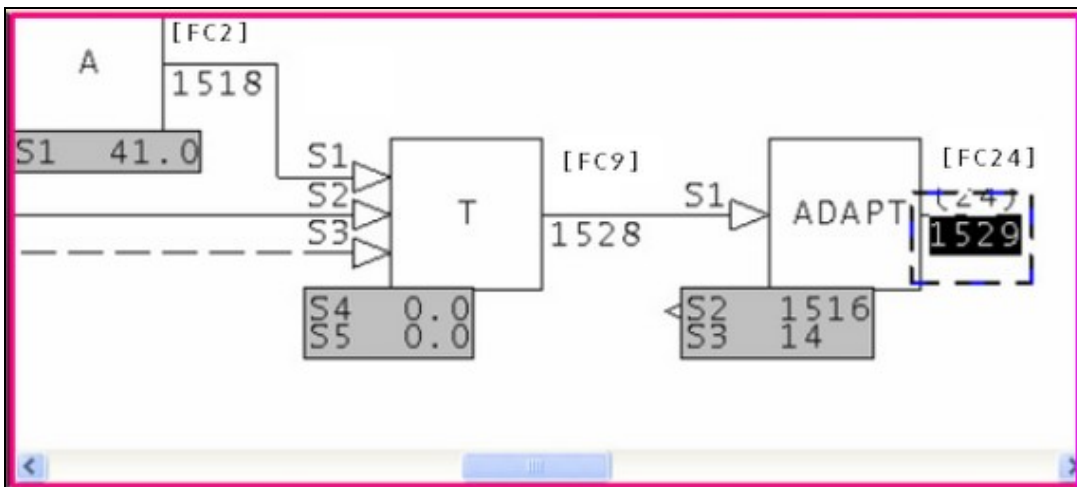
Adapt block Module 4,50,02 Block 1529 on drawing 45002P3:
 Spec 14 on block 1516 out of range, (function code 40).

Click on the link in the error browser to bring up the CLD/CAD sheet where we have an adapt block issue.

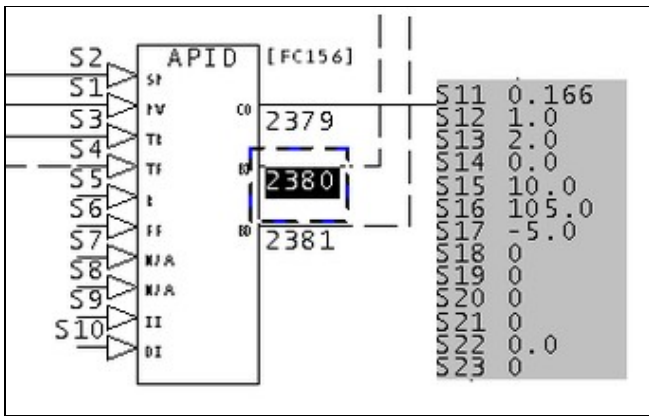
Advanced PID Module 4,50,02 Block 2380 using block increase flag with S19=0.

Both Block Increase BI and Block decrease BD outputs are in use, which is contrary to the documentation. S19 = 0, indicating the quick recovery form of the algorithm is being used.

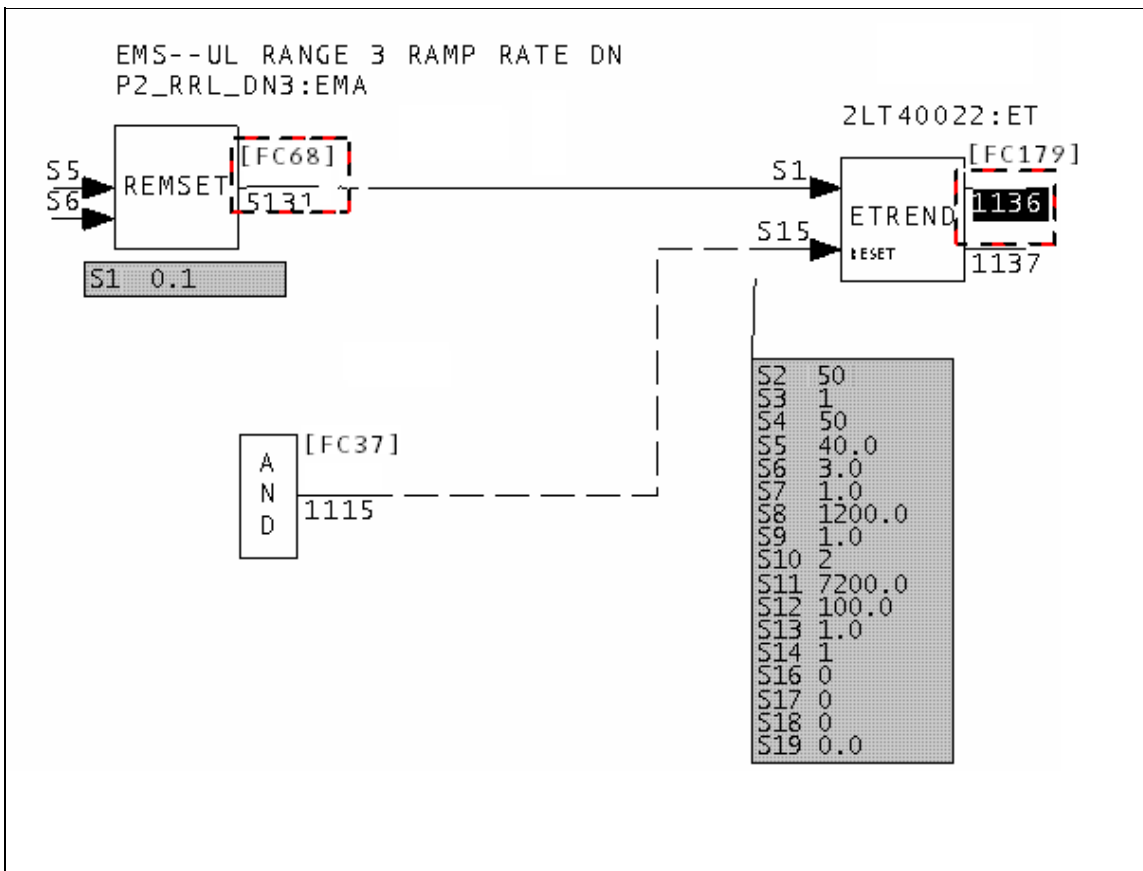
Enhanced Trend: Module 1,01,02 Block 1136 has illegal S2 value 50

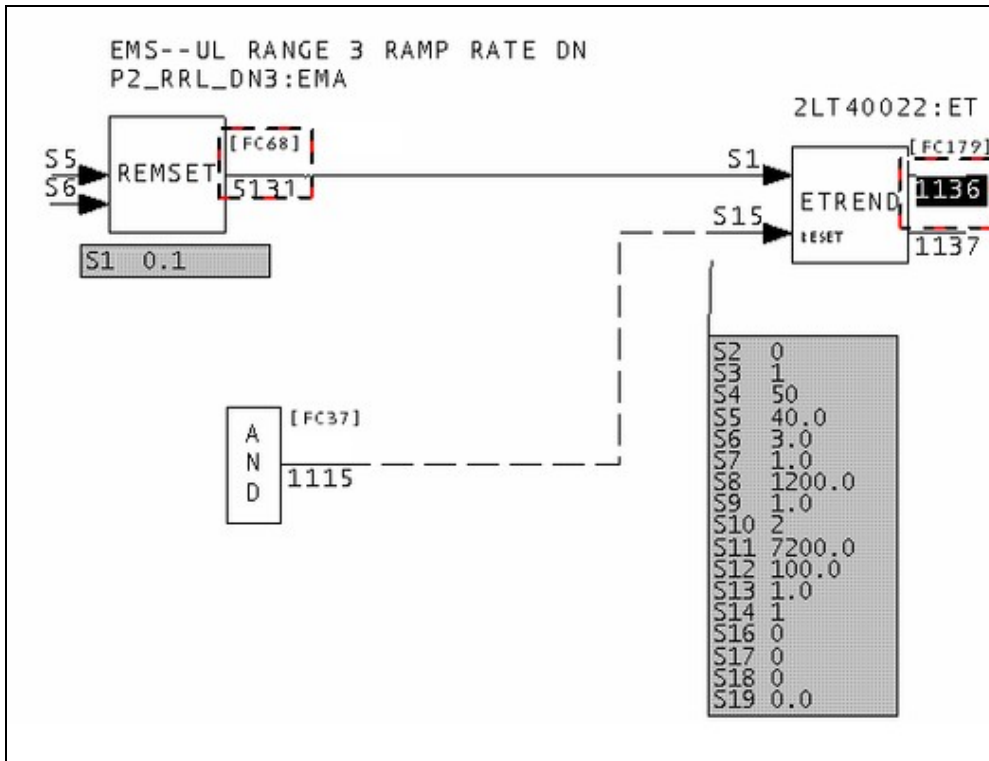
The block addressed in S1 must match the input block type in S2 or a configuration error will result.

Enhanced Trend: Module 1,01,02 Block 1136 S1 is wired from FC 68 Module 1,01,02 Block 5131 but S2 0 specifies FC 30

In this case, S1 is coming from the wrong type of block or S2 should be 3.

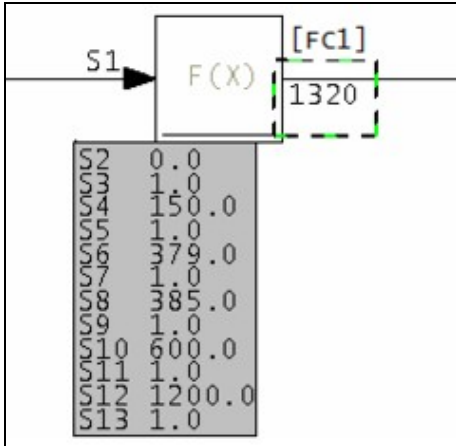
```
--Post Processing drawing 11002B9A.CAD
F(x) Module 1,01,02 Block 1320 graph is flat - value 1.00.
```

Notice that the Y value is 1.0 for all values of the input X value – that is, a constant.

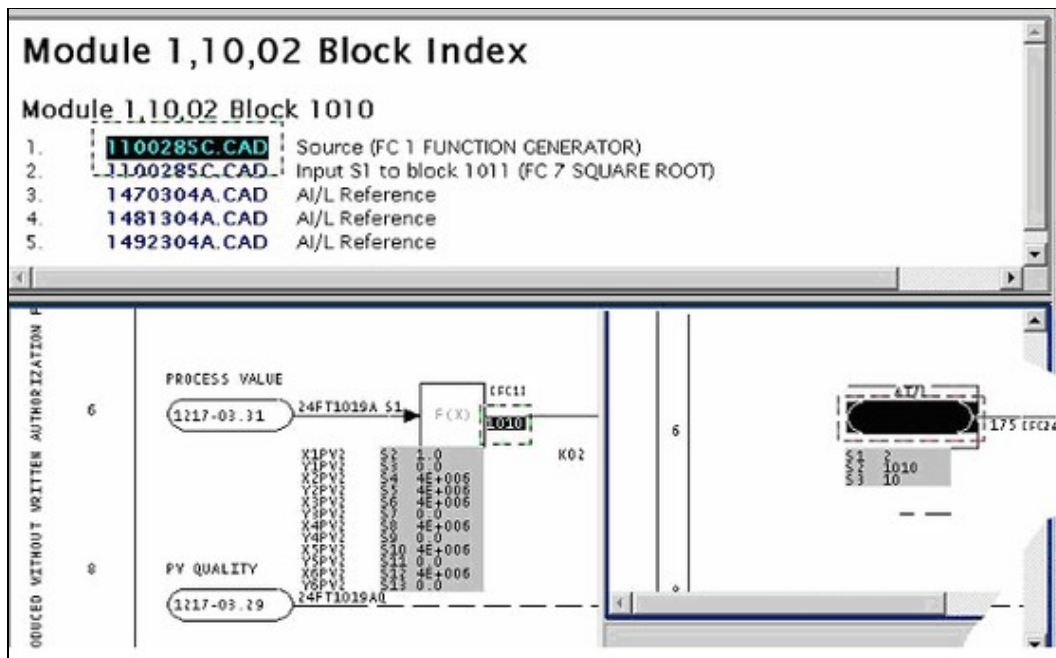
This example shows the attempt to use an AI/L block to import the output of a F(x) FC 1 block, which is not an exception report.

Often, this error leads to uncovering unused or reused logic. Blocks are sometimes used without the knowledge that their values are being imported in another module, PCU or loop. You get a check for this situation on every DBDOC build.

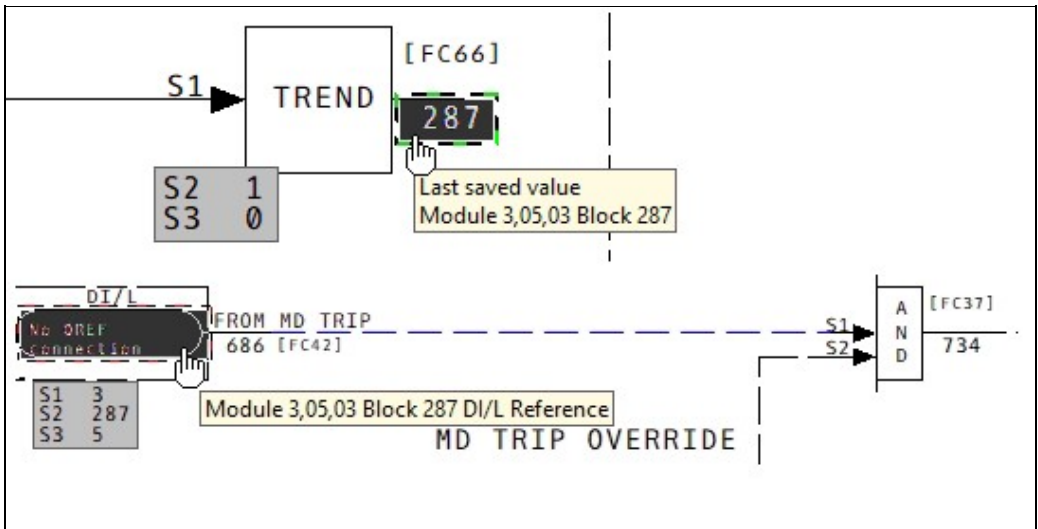
Data type mismatch: DI/L Reference on drawing 3070341 attempts to import analog value from Module 3,05,03 Block 287

This message is likely to show an error in the system configuration. It should be reviewed. The issue raised may be in unused logic or graphics, or have other realities that make it a non-issue.

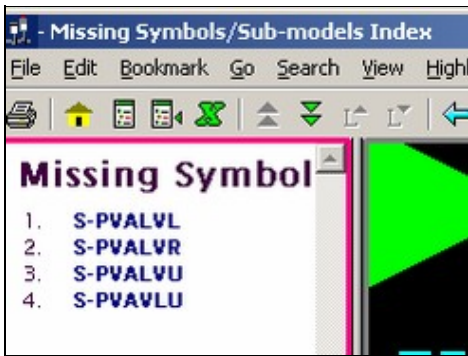
DBDOC makes links to these missing symbols for you. For the example above, you can see this here.

The Missing Symbols Index lists all missing symbols, and each symbol has a list and link to the graphics it is supposed to be found on. DBDOC thus makes it easy to find where these symbols are on the graphic so you can solve the problem that the missing symbol represents.

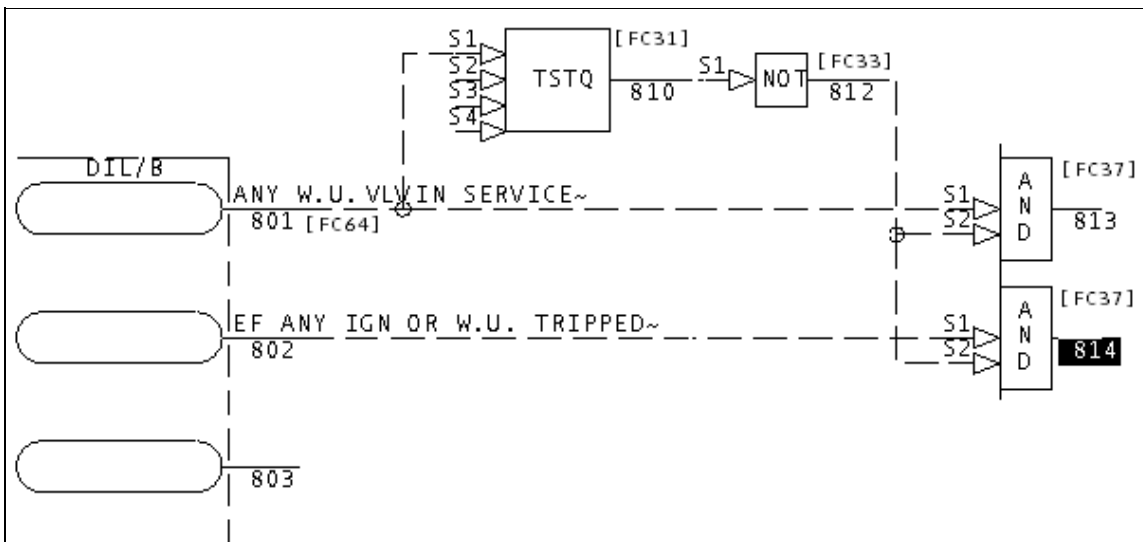
```
--Parsing file E:\...\RI_UNI~4\EBY1E5C.CLD...  
Module 8 for IREF MILL GROUP F IN SERVICE~ (S3) does not match module 0 (S2) in file -- skipping.  
Module 4 for IREF ANY W.U. VLV IN SERVICE~ (S3) does not match module 2 (S2) in file -- skipping.  
Module 4 for IREF EF ANY IGN OR W.U. TRIPPED~ (S4) does not match module 2 (S2) in file -- skipping.
```

Looking at the logic, you can see that what has happened is that an unused DI/L block has been put on a boneyard sheet. The natural outputs, blocks 813 and 814, are not used anywhere else.

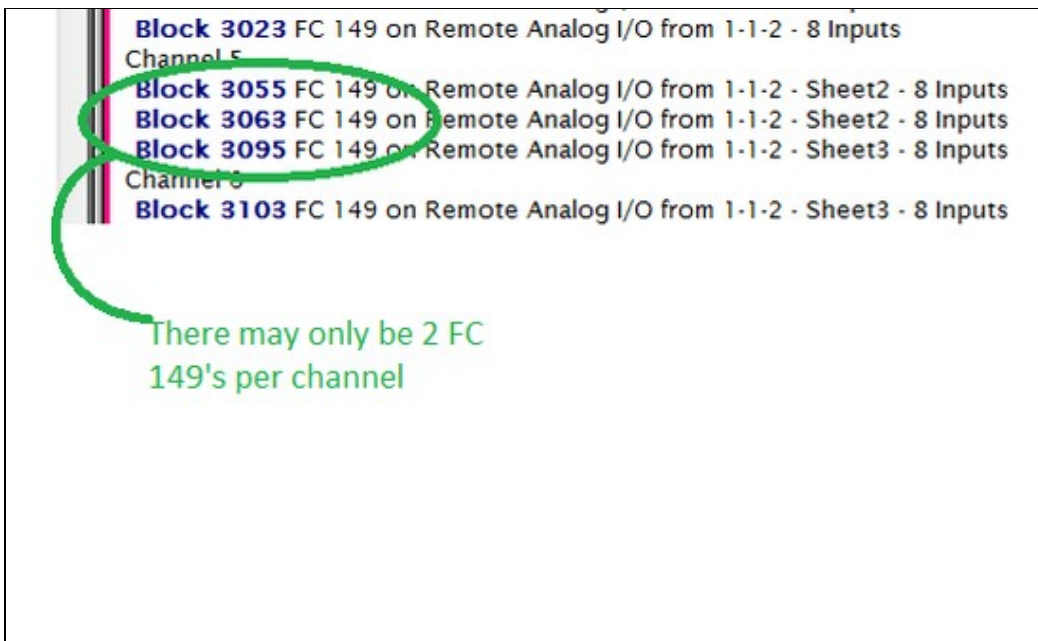
Multiple slave FCs on Module 1,01,02 slave 15: 3 FC 149's, limit is 2 (Module 1,01,02 Header)

DBDOC's analysis of the configuration of your slave specs suggests that there are too many slaves on an ASO: Analog Output/Slave [FC149] block.

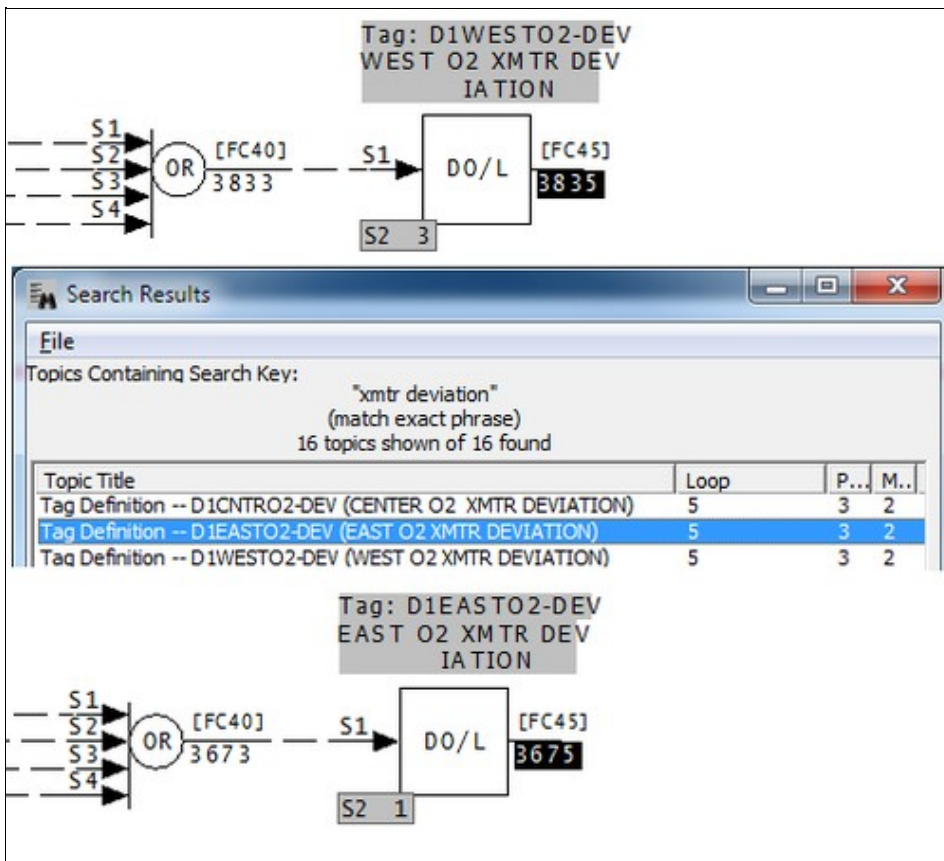
```
Module 5,03,02 Block 3835 FC45 S2 value 3 is out of the valid range [0,2]
```

You can see the error, and also how a simple search finds the complementary tag, with a valid specification

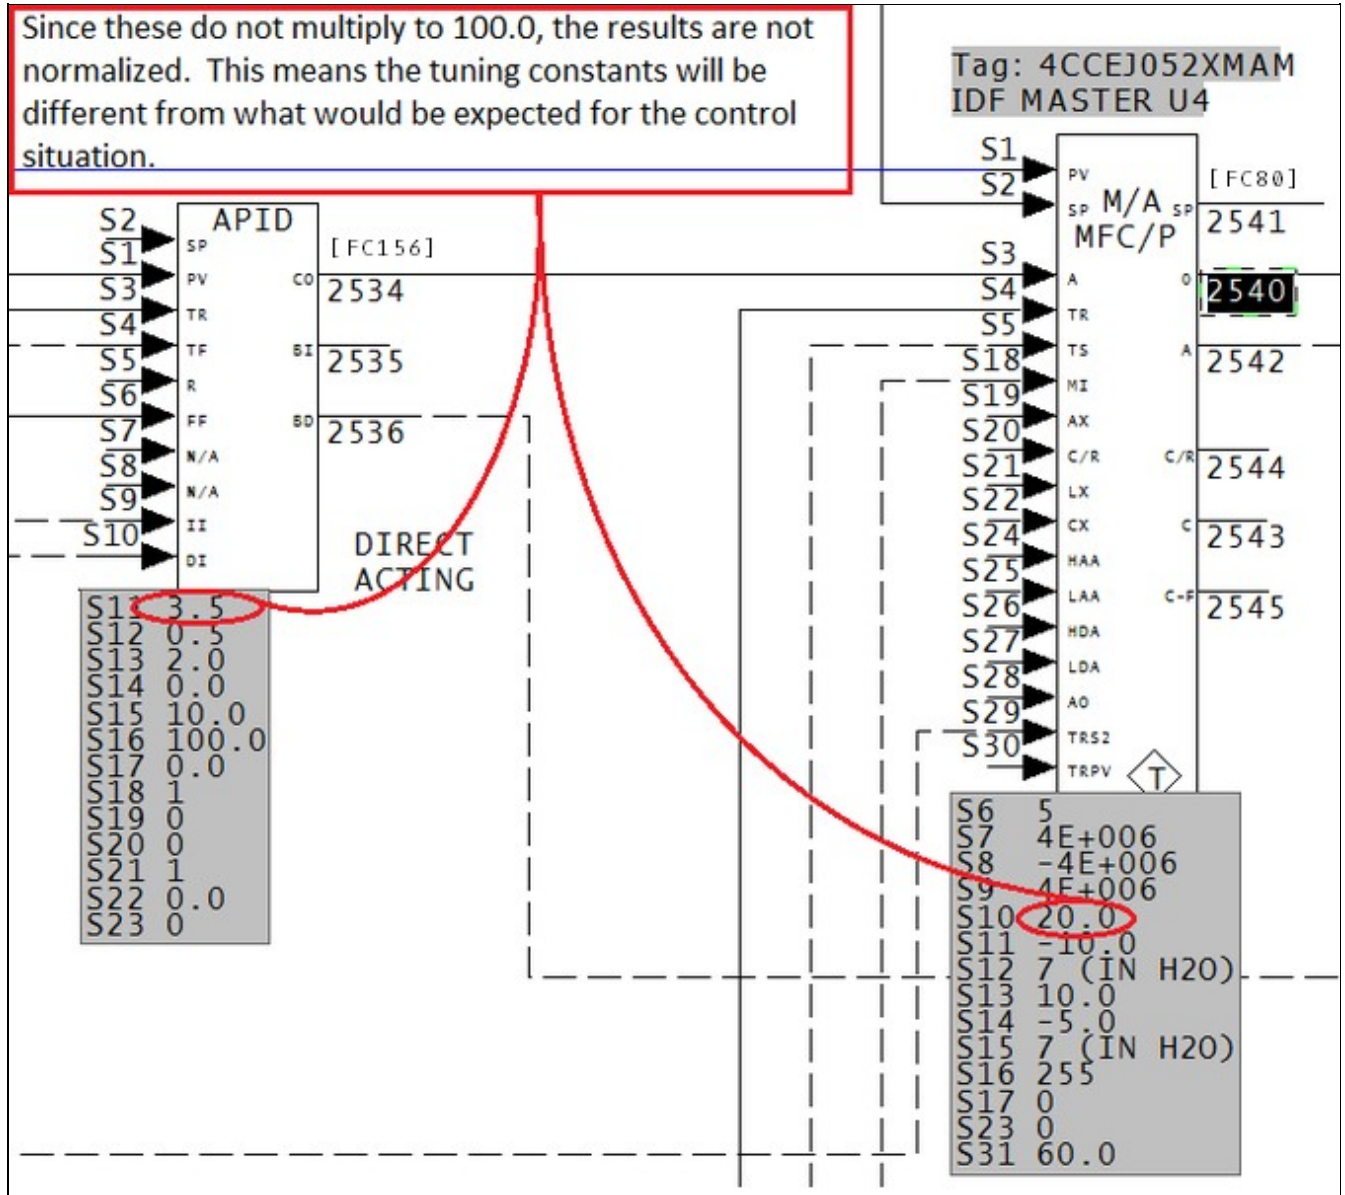
These messages show where that situation does not exist. These blocks can be tuned, but the tuning constants will not be "normalized" and thus will be subject to misinterpretation.

The product of S11 on the APID and the S10 on the M/A MFC/P must fall in the range of 80 to 125. This error occurs when the product is below that range.

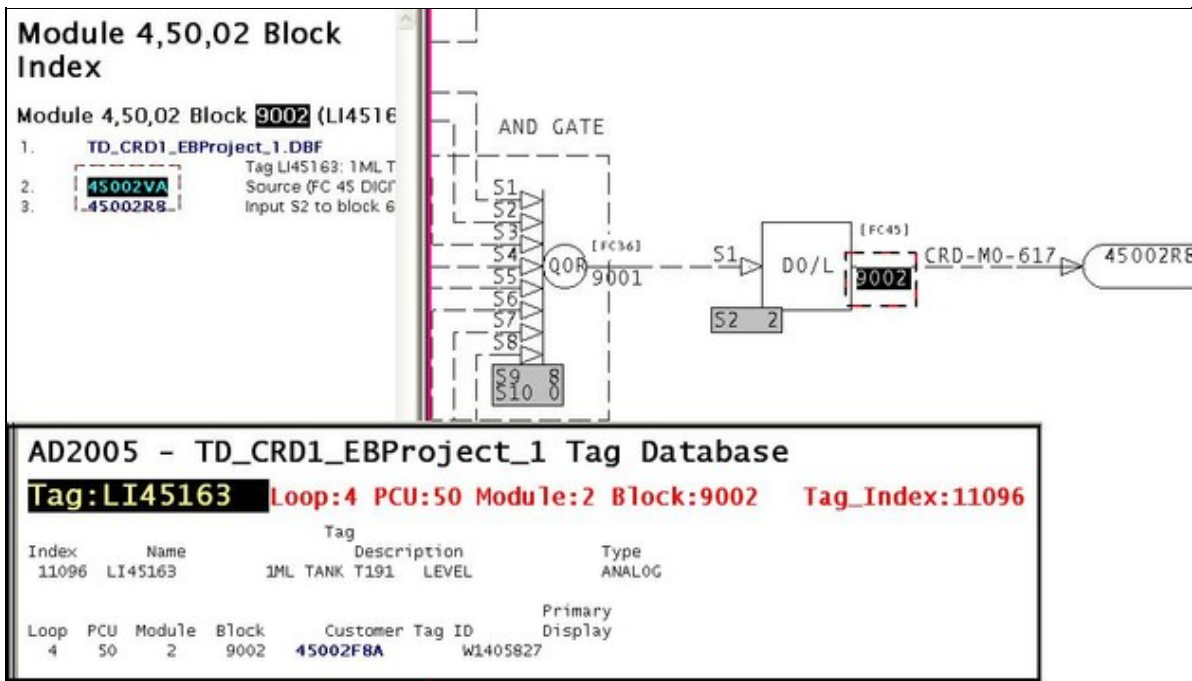
The snippet from the CLD/CAD sheet source shows that the block is a digital block but the tag definition says it is an ANALOG tag, which is why there is a note about a mismatch.

If an operator tries to make changes on a tag that is defined with the wrong type, those changes will not work.
